SOIL-CEMENT FOR WATER RESOURCES APPLICATIONS

Soil-Cement Stands the Test of Near Record Breaking Rainfall in Southern California

Mark E. Krebs, P.E.

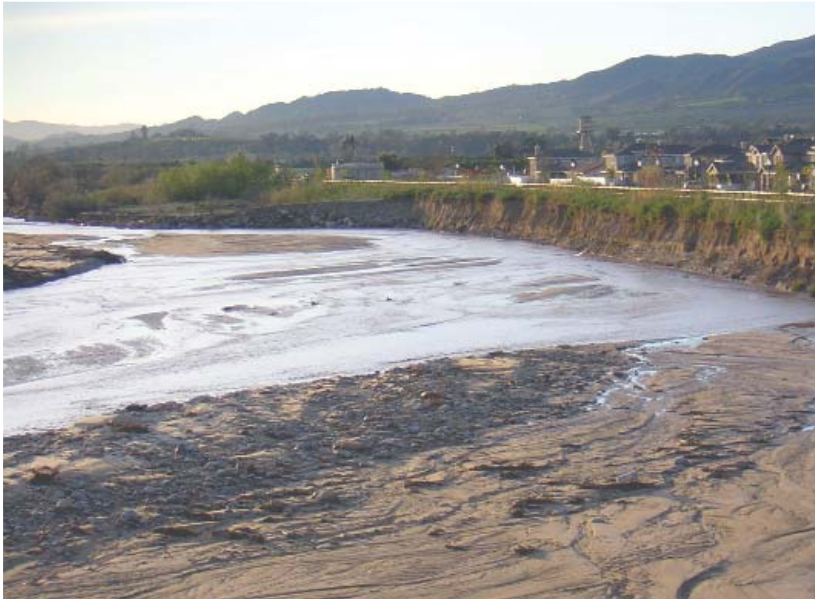
Buried soil-cement protects embankment following erosion of re-vegetated soil cover.

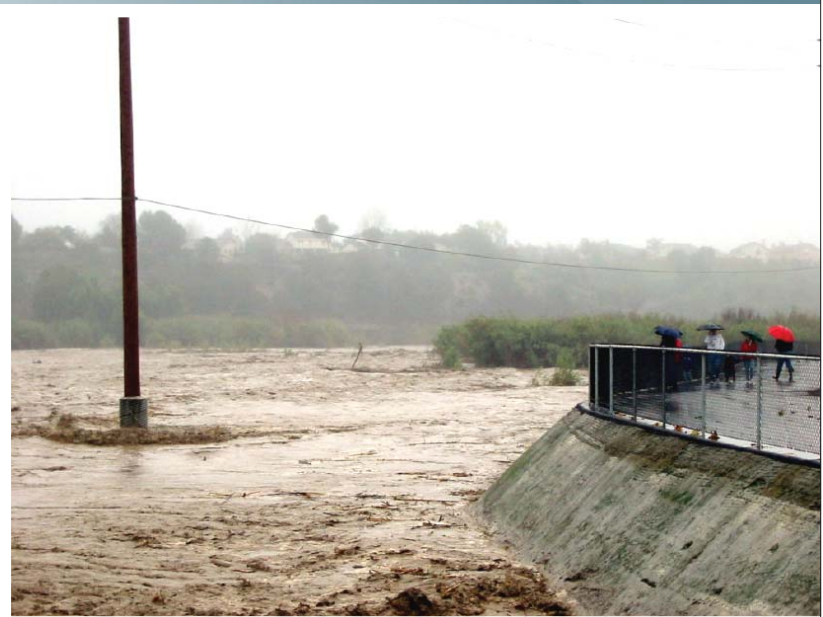
Exposed soil-cement embankment protection withstands flood waters.

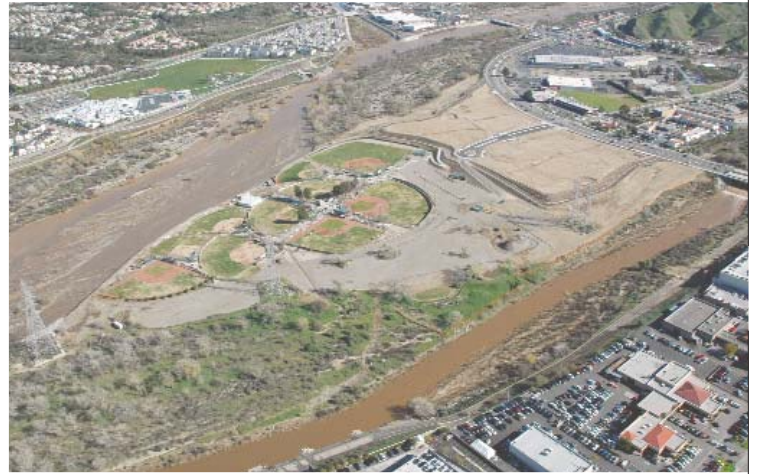
Arial view of Hart Baseball Fields, Santa Clarita, CA during January 2005 storms.

A major test of soil-cement bank protection came during the heavy rains for the 33-acre (13.4 hectare) site of the William S. Hart Baseball & Softball League fields in Santa Clarita. Historically, this area has been subject to major flooding during even minor rain events. In response, Newhall Land commissioned 3,500 linear feet (1,067 m) requiring 25,000 cubic yards (19,100 m³) of soil-cement bank protection to be placed along the Santa Clara River and South Fork confluence. The cement content ranged from 6.5% to 8%. Construction of the bank protection was complete in the fall of 2004, just in time for the rainy season. In January 2005, when a large portion of the major storm events took place, baseball tryouts went on as scheduled since no areas on the site were compromised by flooding.

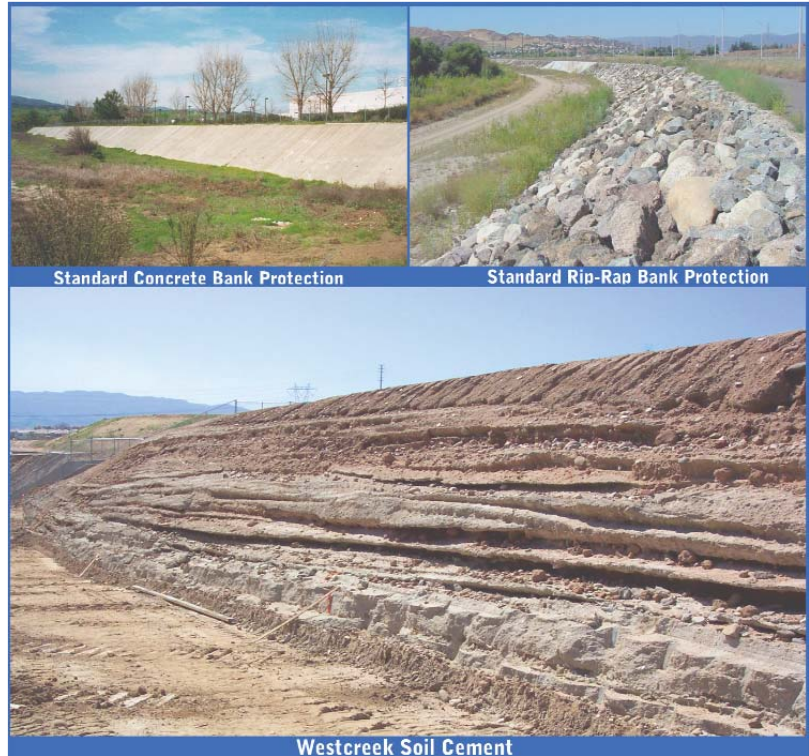
Bank Protection Alternatives.

Standard Concrete Bank Protection

Standard Rip-Rap Bank Protection

Westcreek Soil Cement

of soil-cement bank protection. It has both buried-revegetated and exposed conditions. The buried-revegetated areas appear undisturbed and the exposed soil-cement bank protection appears as native hardened soil providing a natural appearance along the creek edge. Since the approval of Westcreek, over 37,500 linear feet (11,400 m) or 290,000 cubic yards (221,700 m³) of soil-cement bank protection has been constructed in LA County, and there are plans for future construction of more than 75,000 linear feet (22,900 m).
